TECHNICAL REPORT GL-86-17

TECHNICAL EVALUATION REPORTS OF AIRFIELD DAMAGE REPAIR SOLUTION

Final Report

**Field Test of Small Crater Repair Utilizing
Regulated Set Concrete**

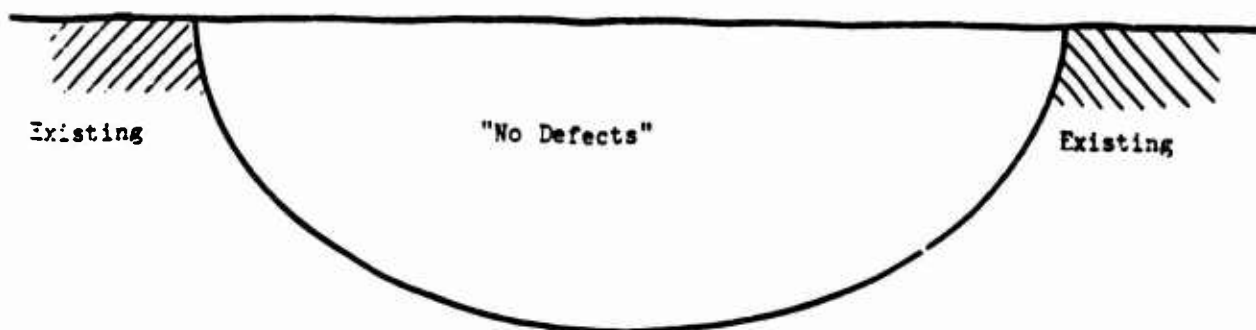
Figure A7. Side view of test strip, 1B-1R

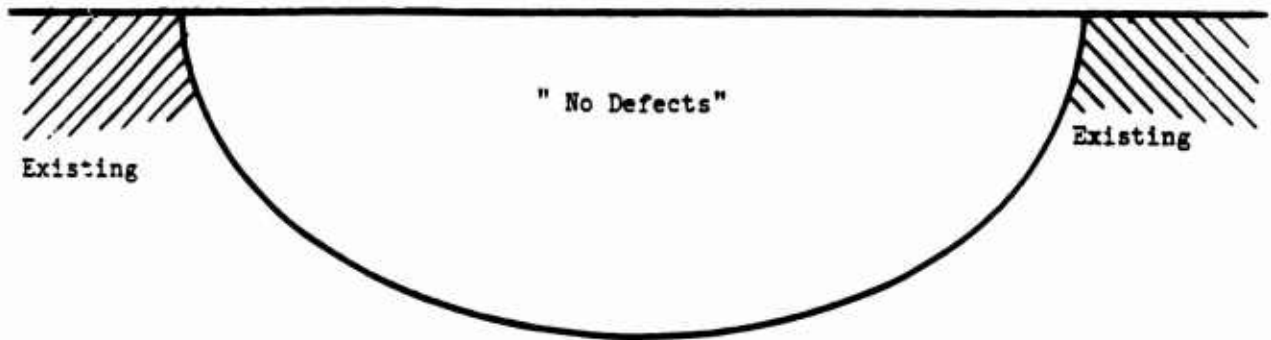
Figure A7. Side view of test strip 1B-1H
